## Chapter 9

# FIRE BEHAVIOR IN WORLD TRADE CENTER 2

### 9.1 INTRODUCTION

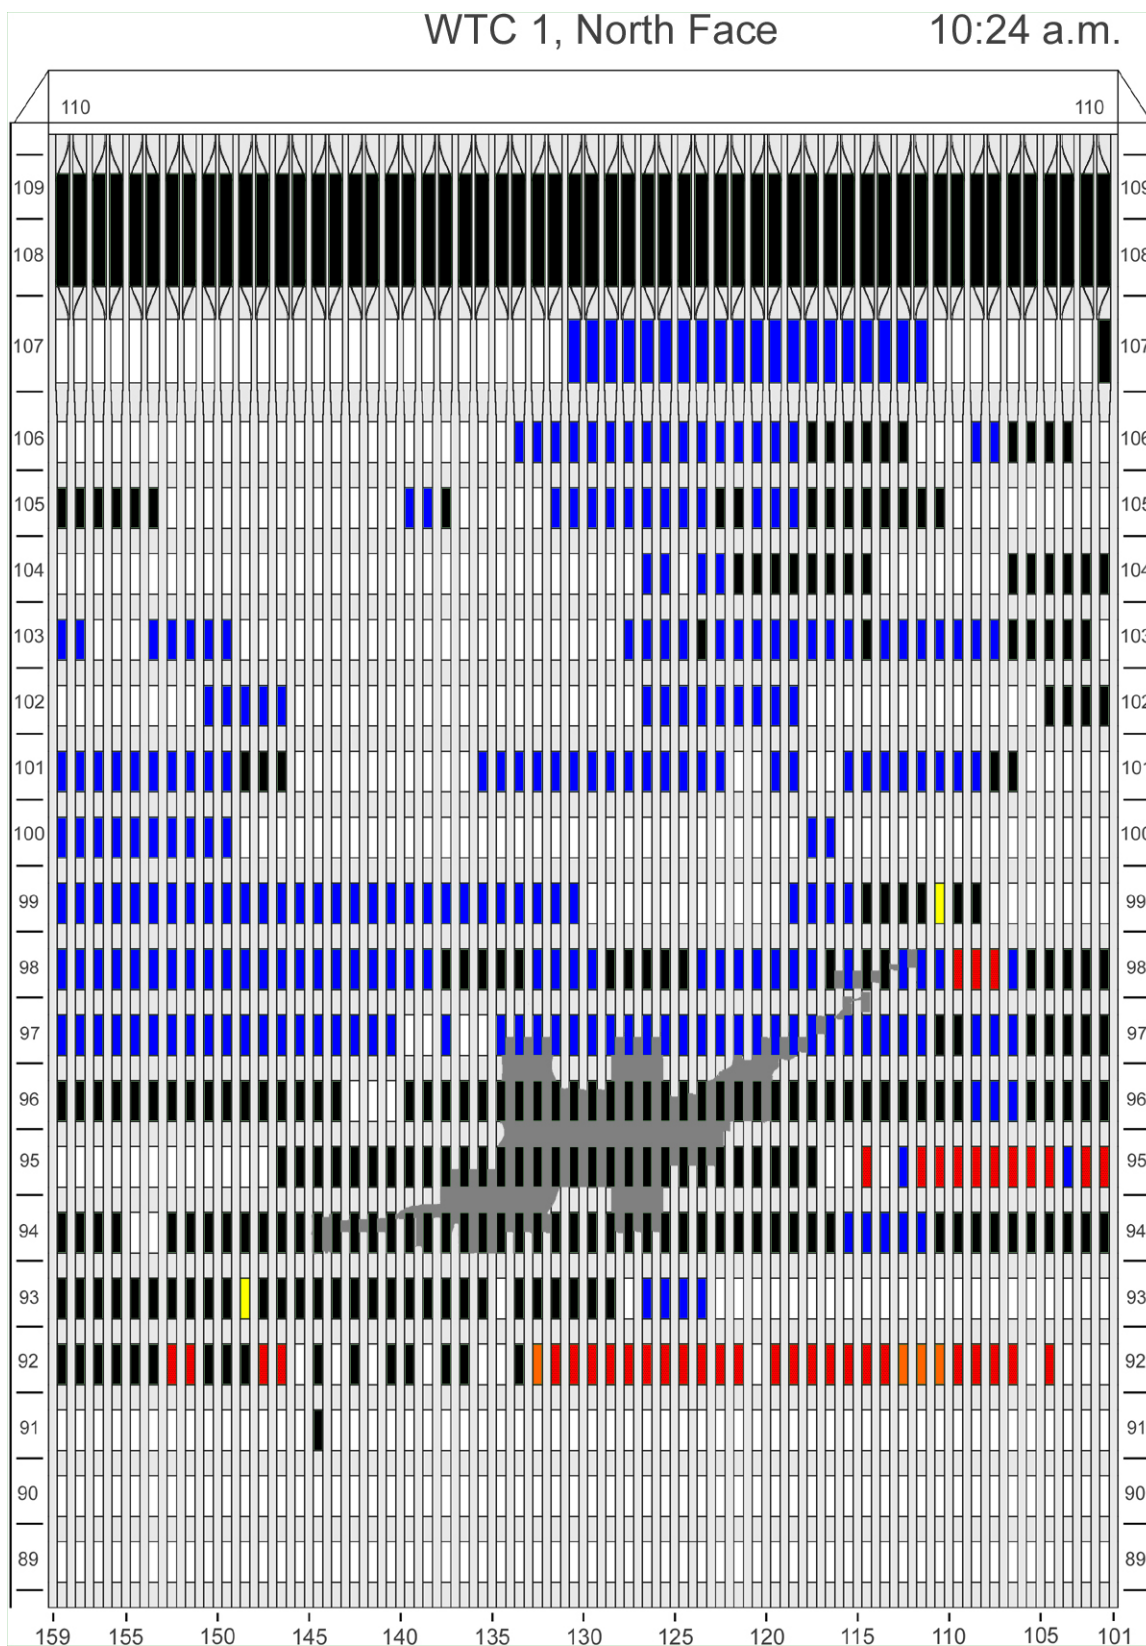
**Figure C-55. Diagram of the north face of WTC 1 for floors 89 to 110 at 10:24 a.m. showing the condition of windows and locations of fires.**

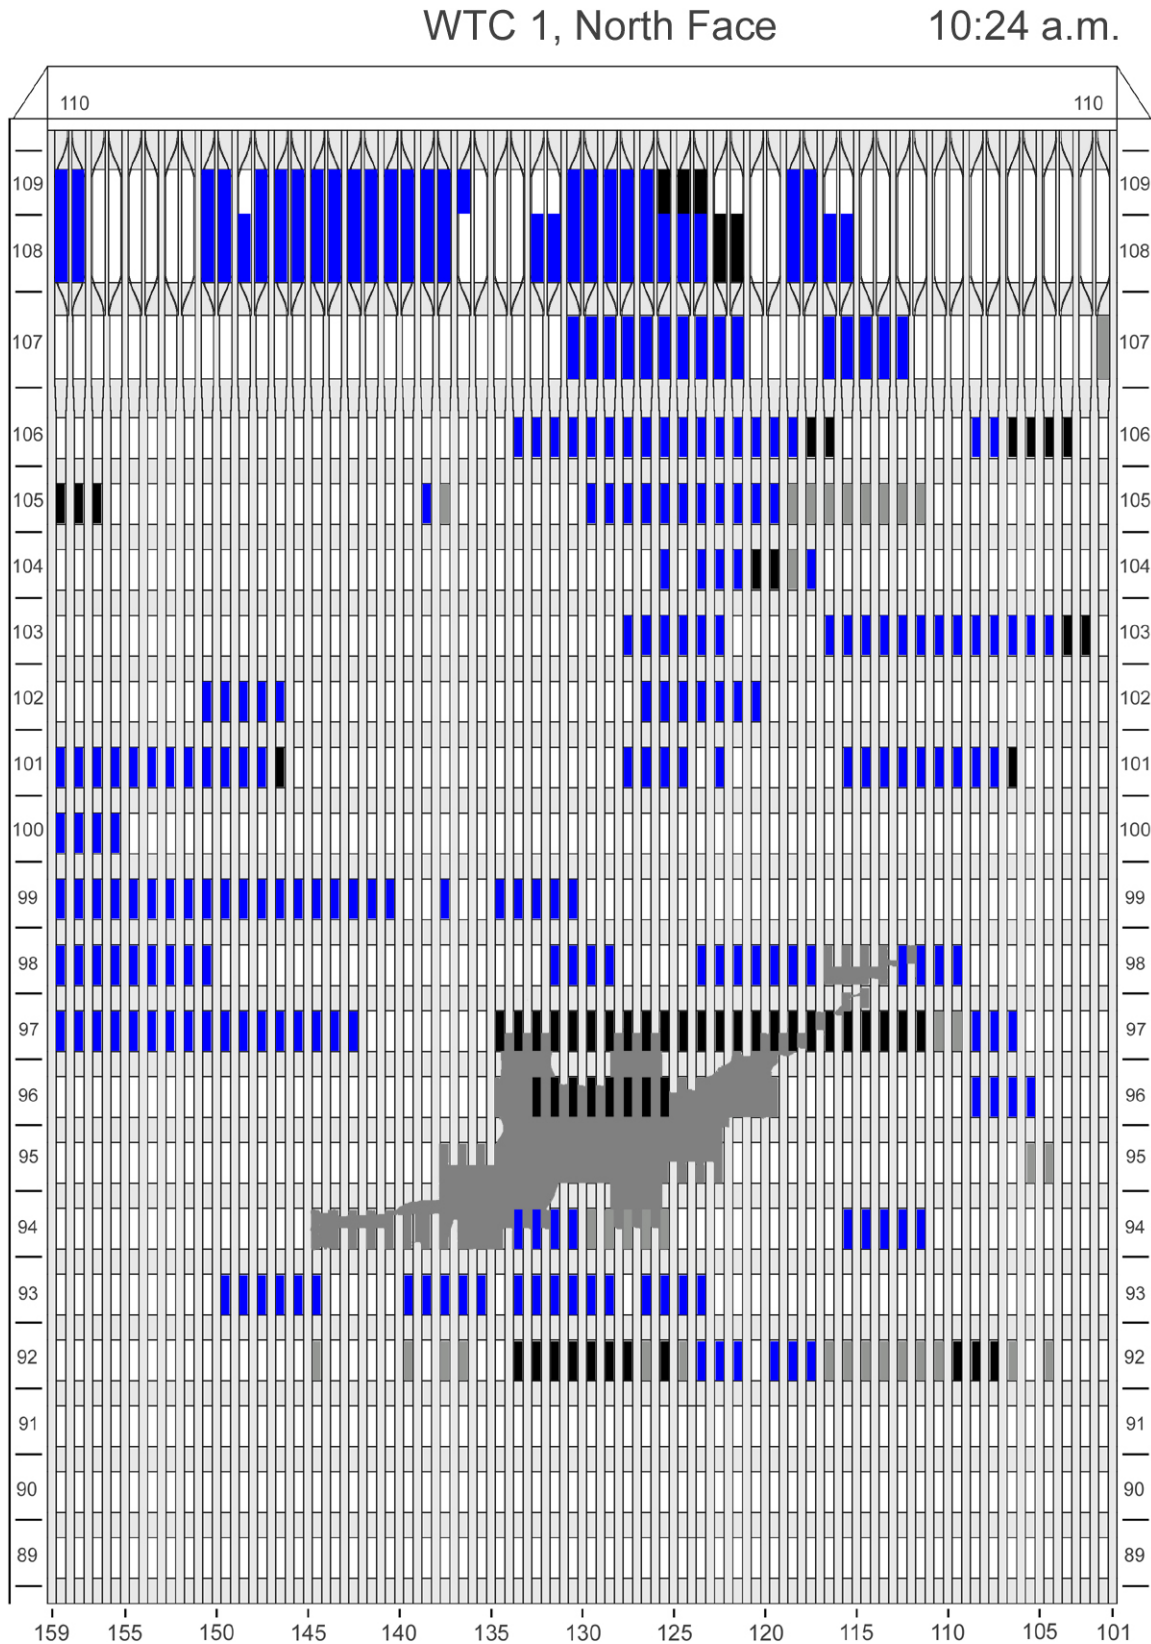
**Figure C-56. Diagram of the north face of WTC 1 for floors 89 to 110 at 10:24 a.m. showing windows where smoke was observed and those that were hidden from view.**

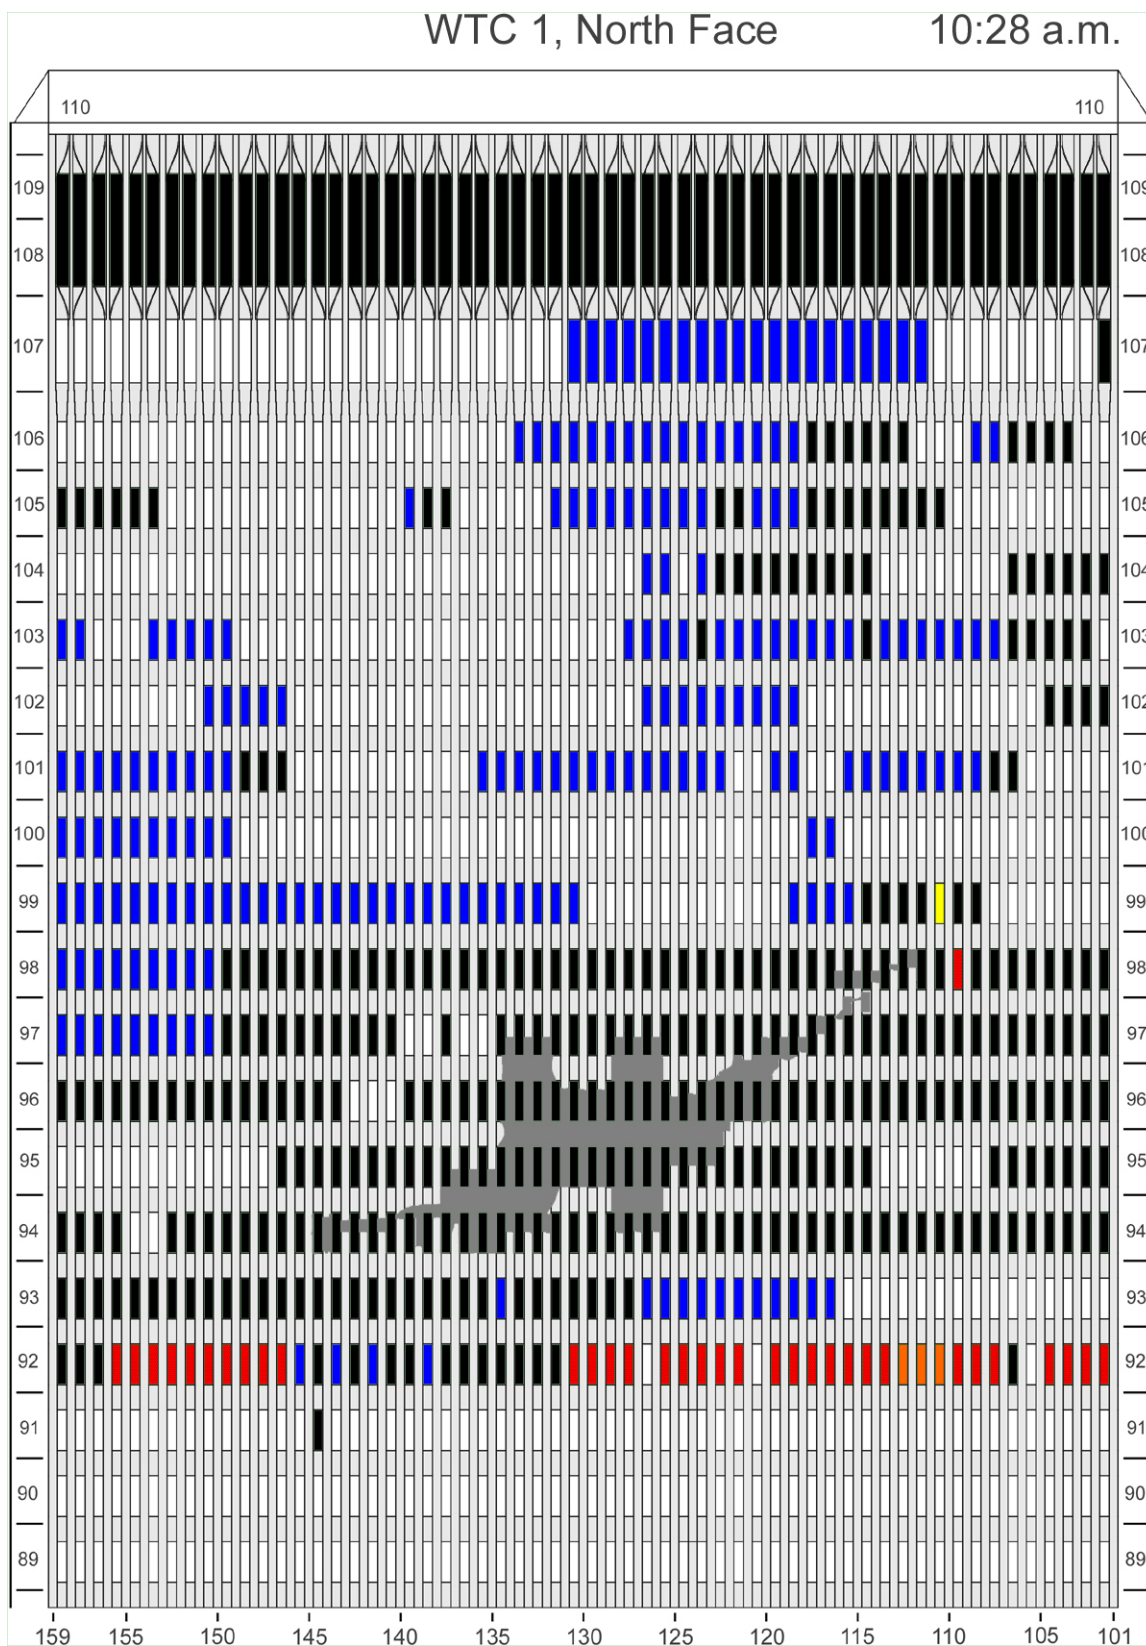
**Figure C-57. Diagram of the north face of WTC 1 for floors 89 to 110 at 10:28 a.m. showing the condition of windows and locations of fires.**

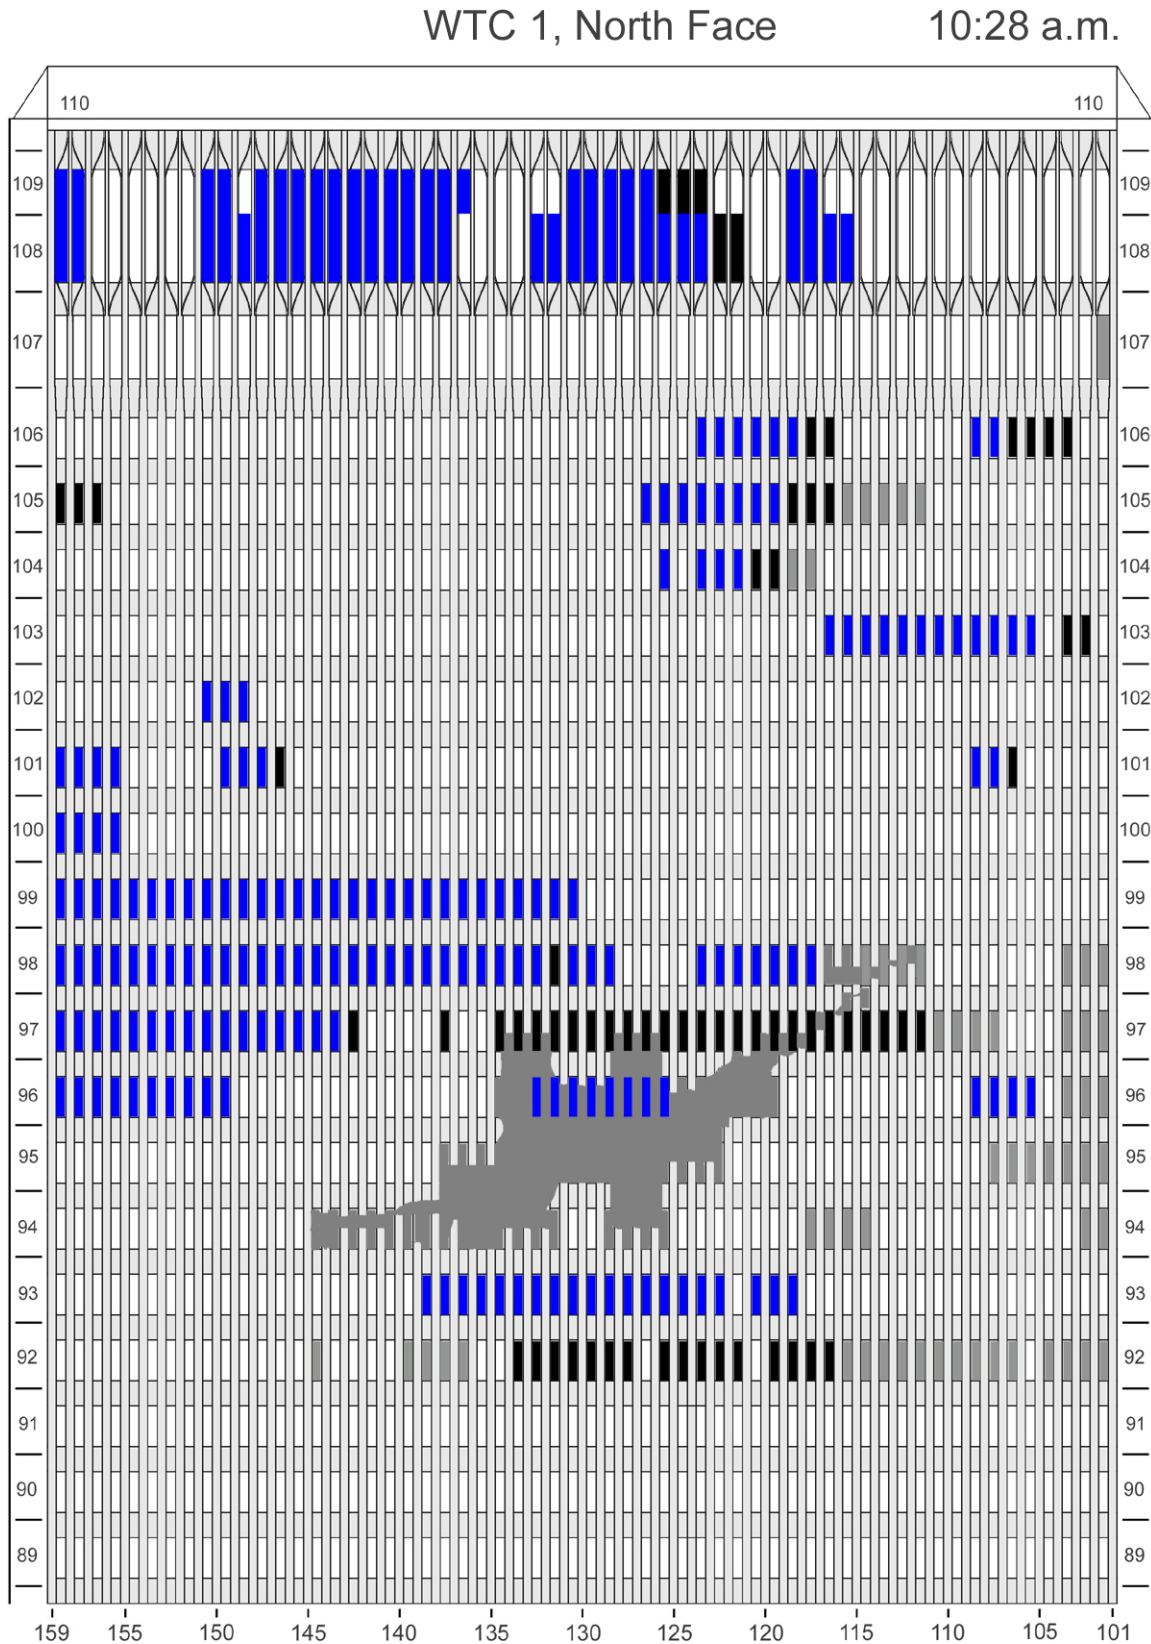
**Figure C-58. Diagram of the north face of WTC 1 for floors 89 to 110 at 10:28 a.m. showing windows where smoke was observed and those that were hidden from view.**

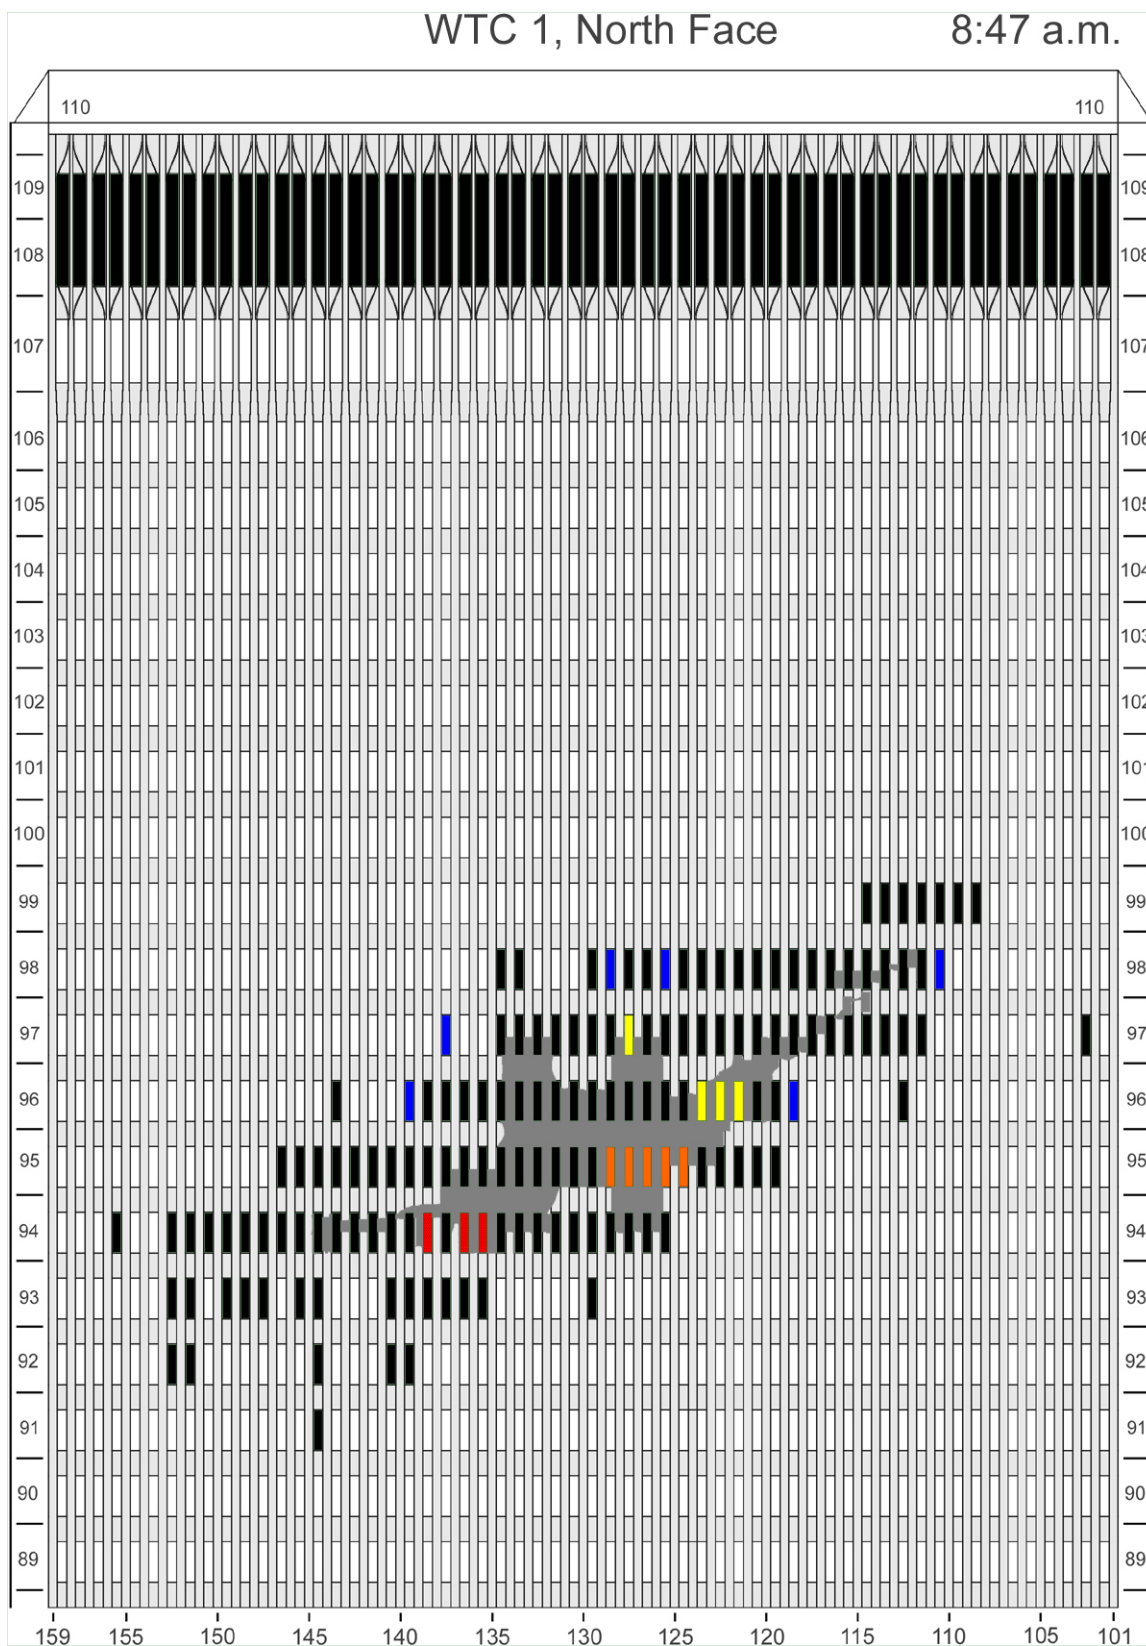
**Figure C-1. Diagram of the north face of WTC 1 for floors 89 to 110 at 8:47 a.m. showing the condition of windows and locations of fires.**

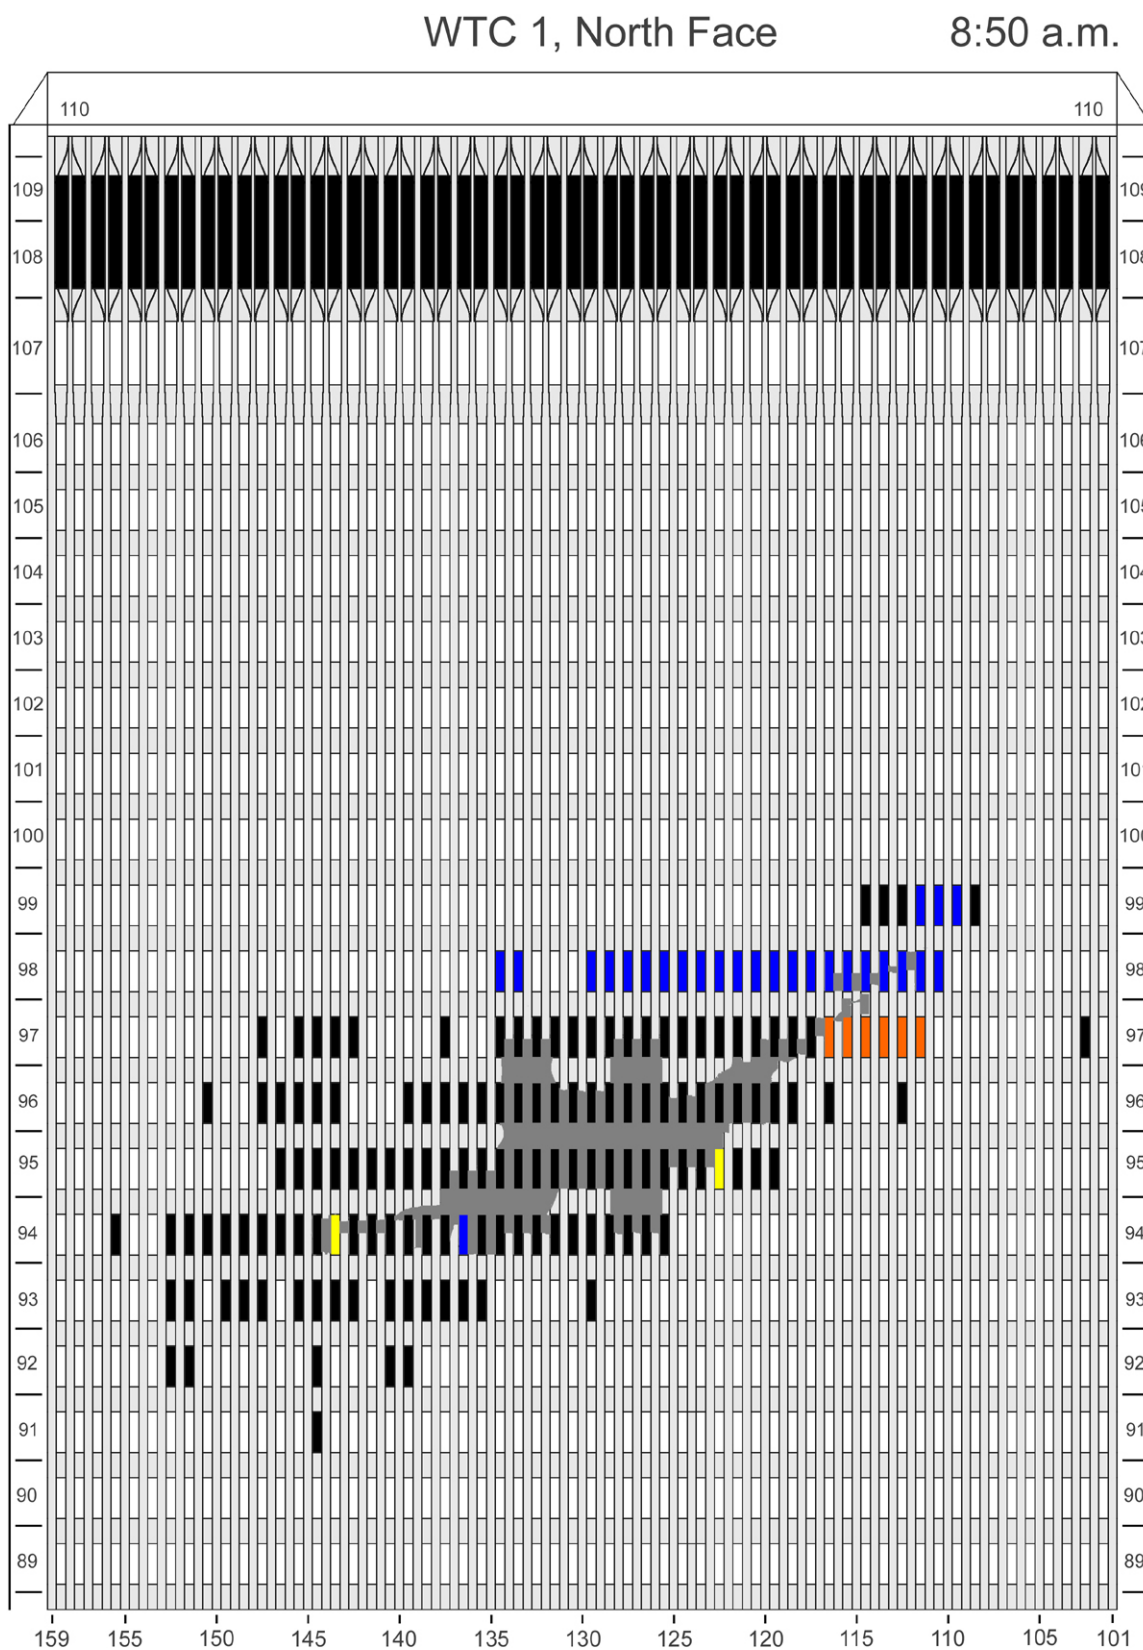
**Figure C-5. Diagram of the north face of WTC 1 for floors 89 to 110 at 8:50 a.m. showing the condition of windows and locations of fires.**

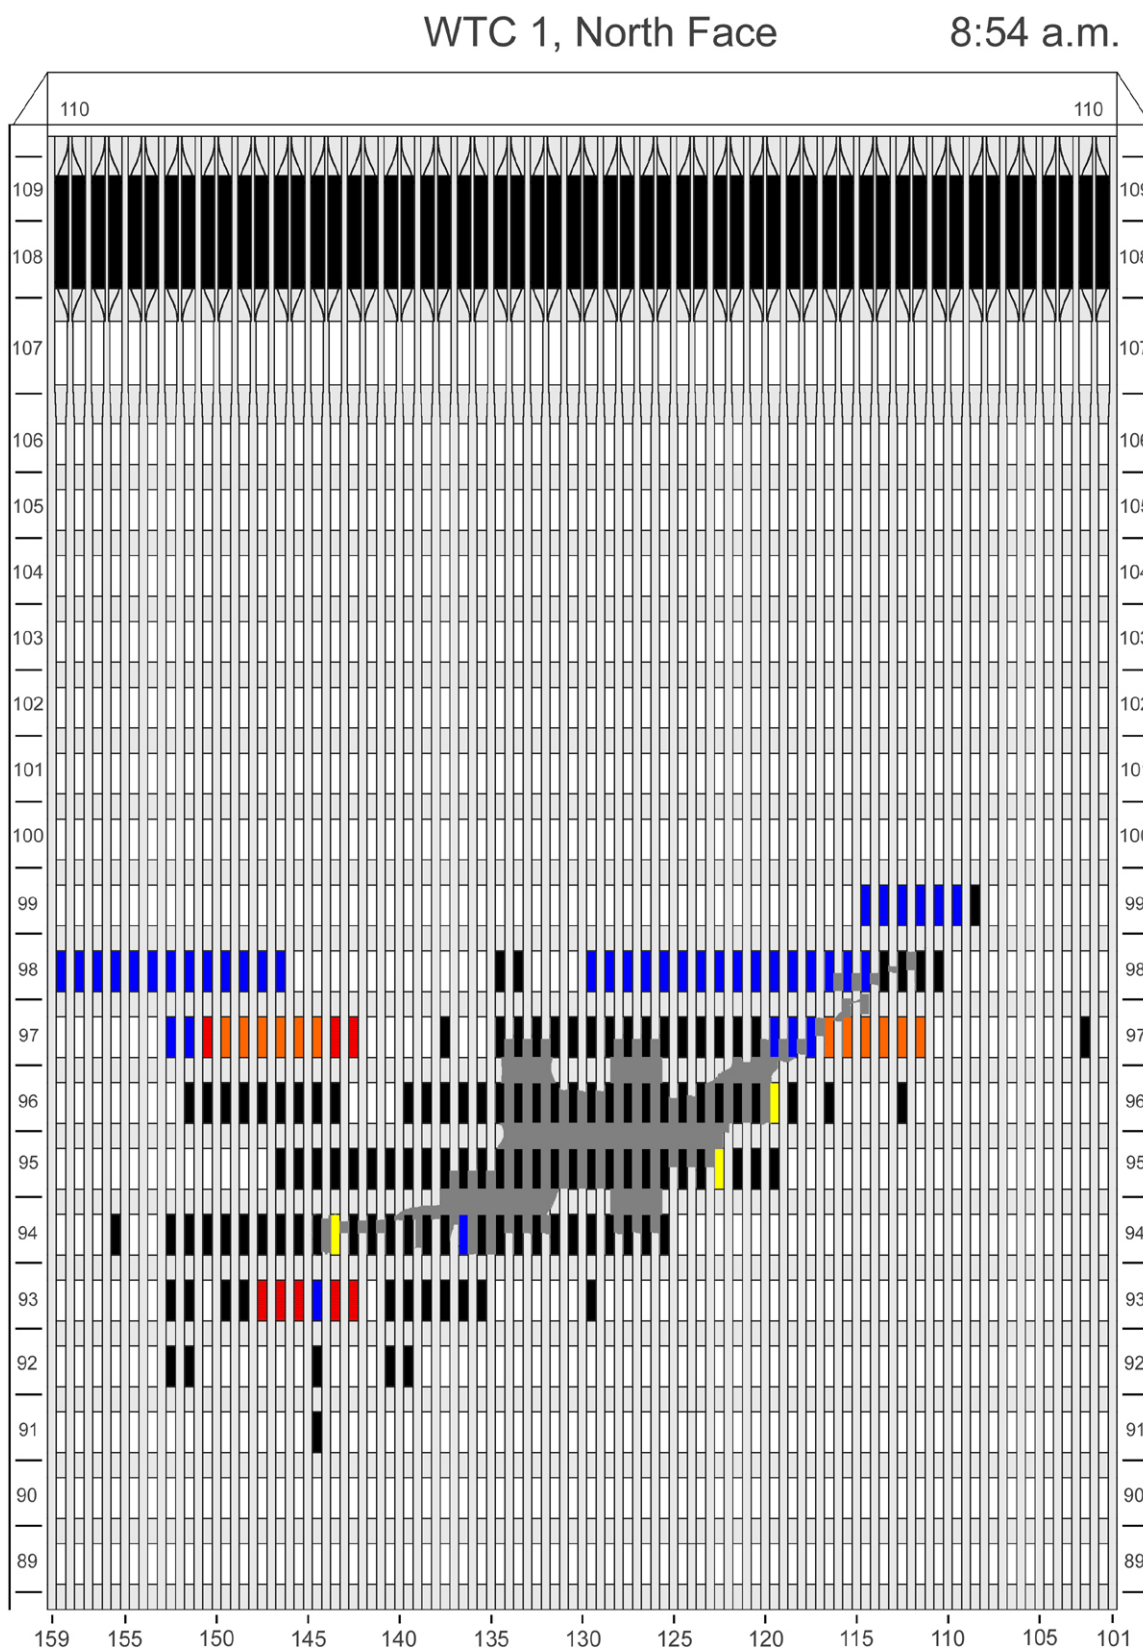
**Figure C-9. Diagram of the north face of WTC 1 for floors 89 to 110 at 8:54 a.m. showing the condition of windows and locations of fires.**

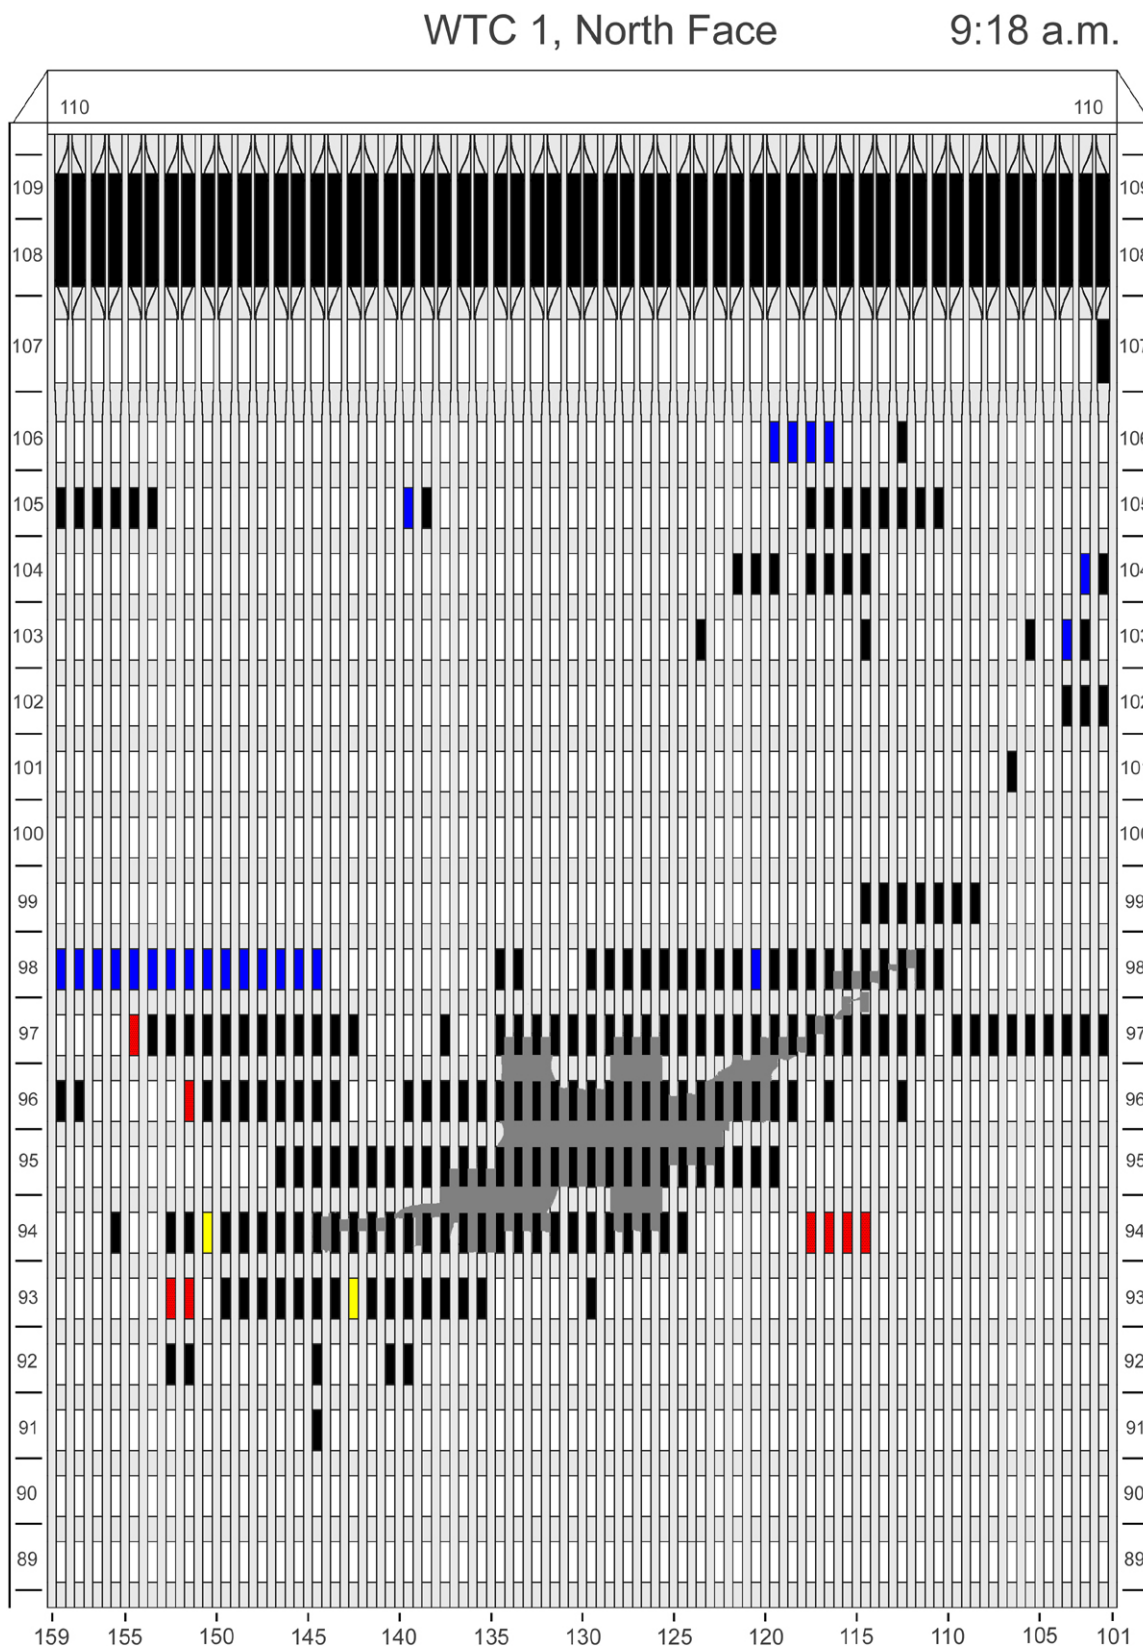
**Figure C-25. Diagram of the north face of WTC 1 for floors 89 to 110 at 9:18 a.m. showing the condition of windows and locations of fires.**

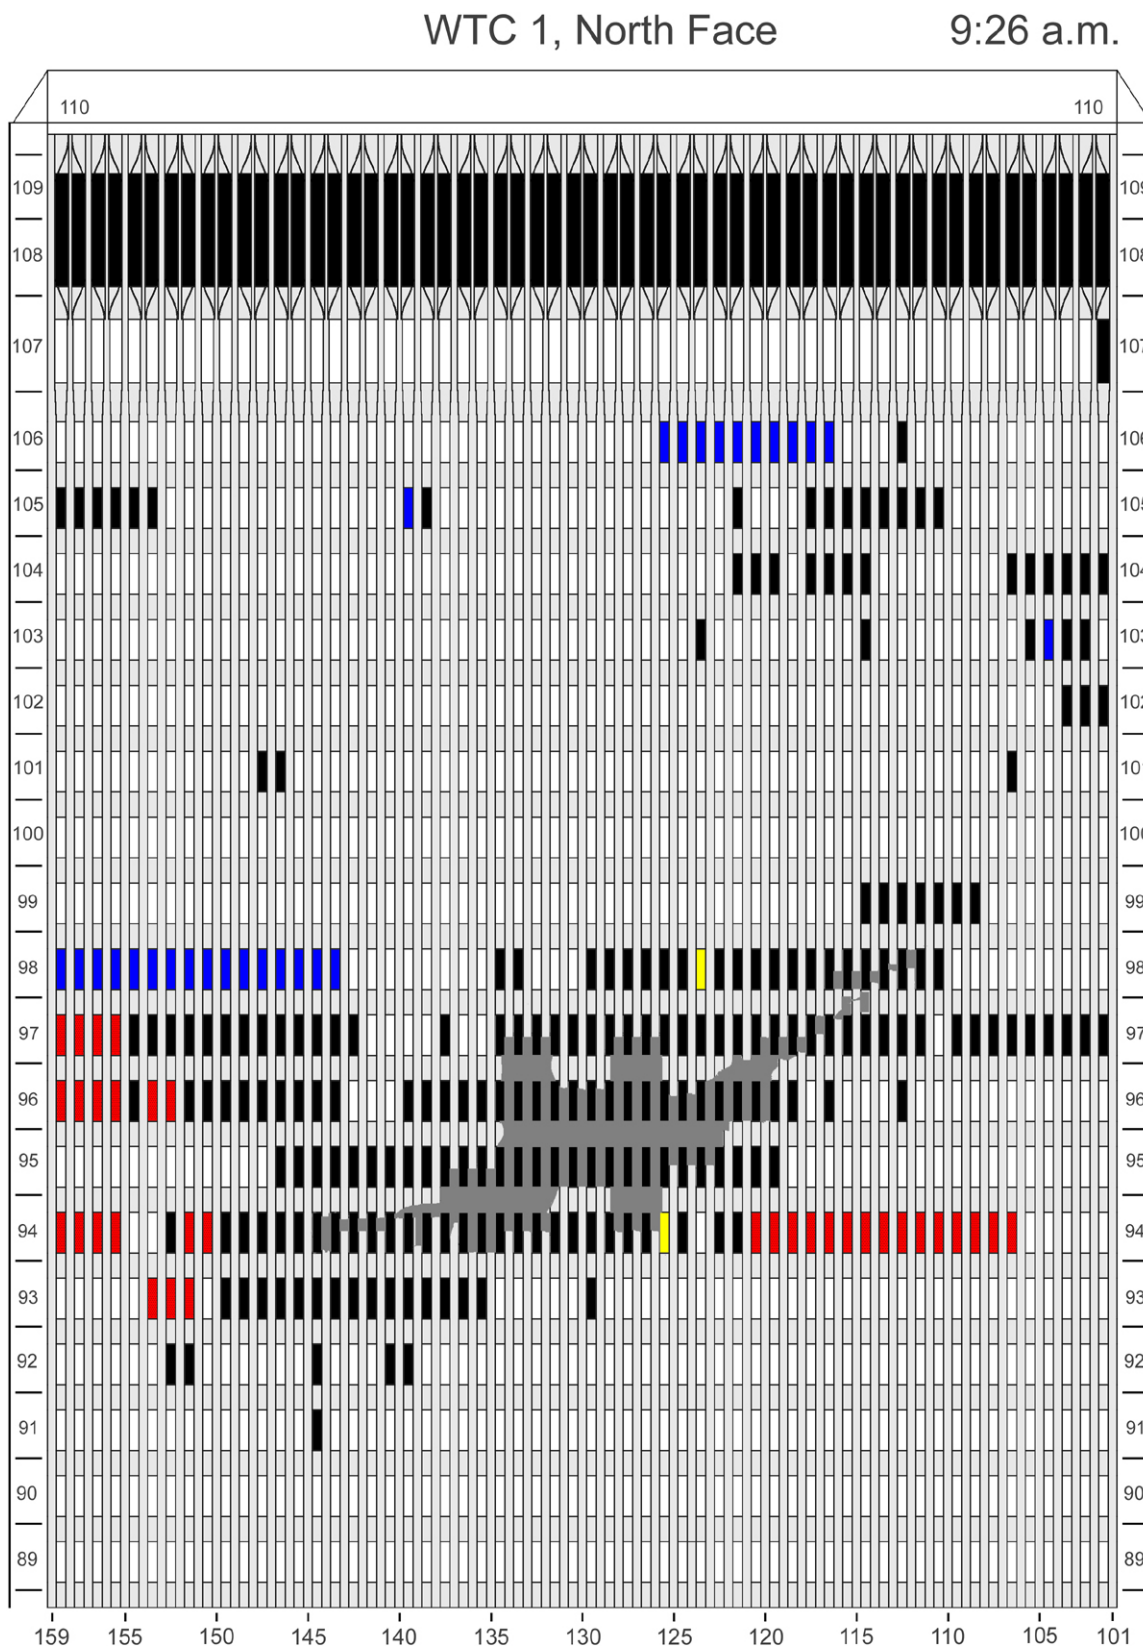
**Figure C-29. Diagram of the north face of WTC 1 for floors 89 to 110 at 9:26 a.m. showing the condition of windows and locations of fires.**

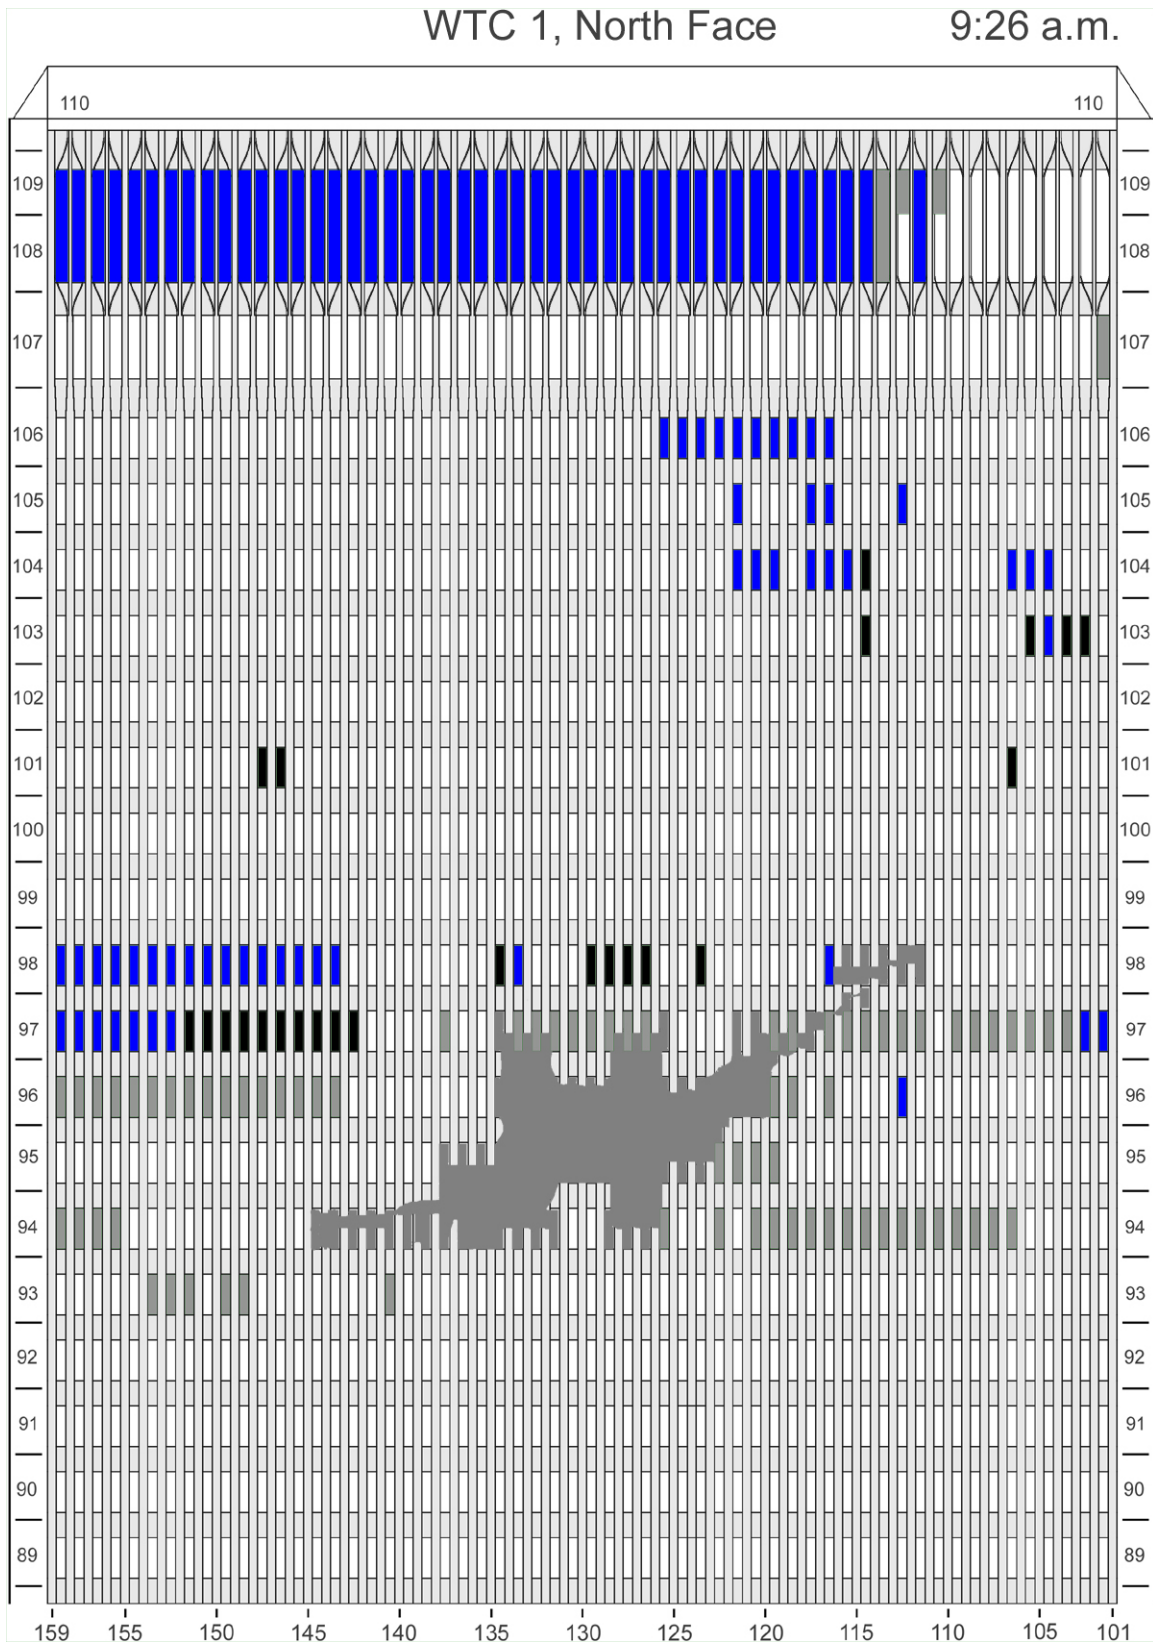
**Figure C-30. Diagram of the north face of WTC 1 for floors 89 to 110 at 9:26 a.m. showing windows where smoke was observed and those that were hidden from view.**

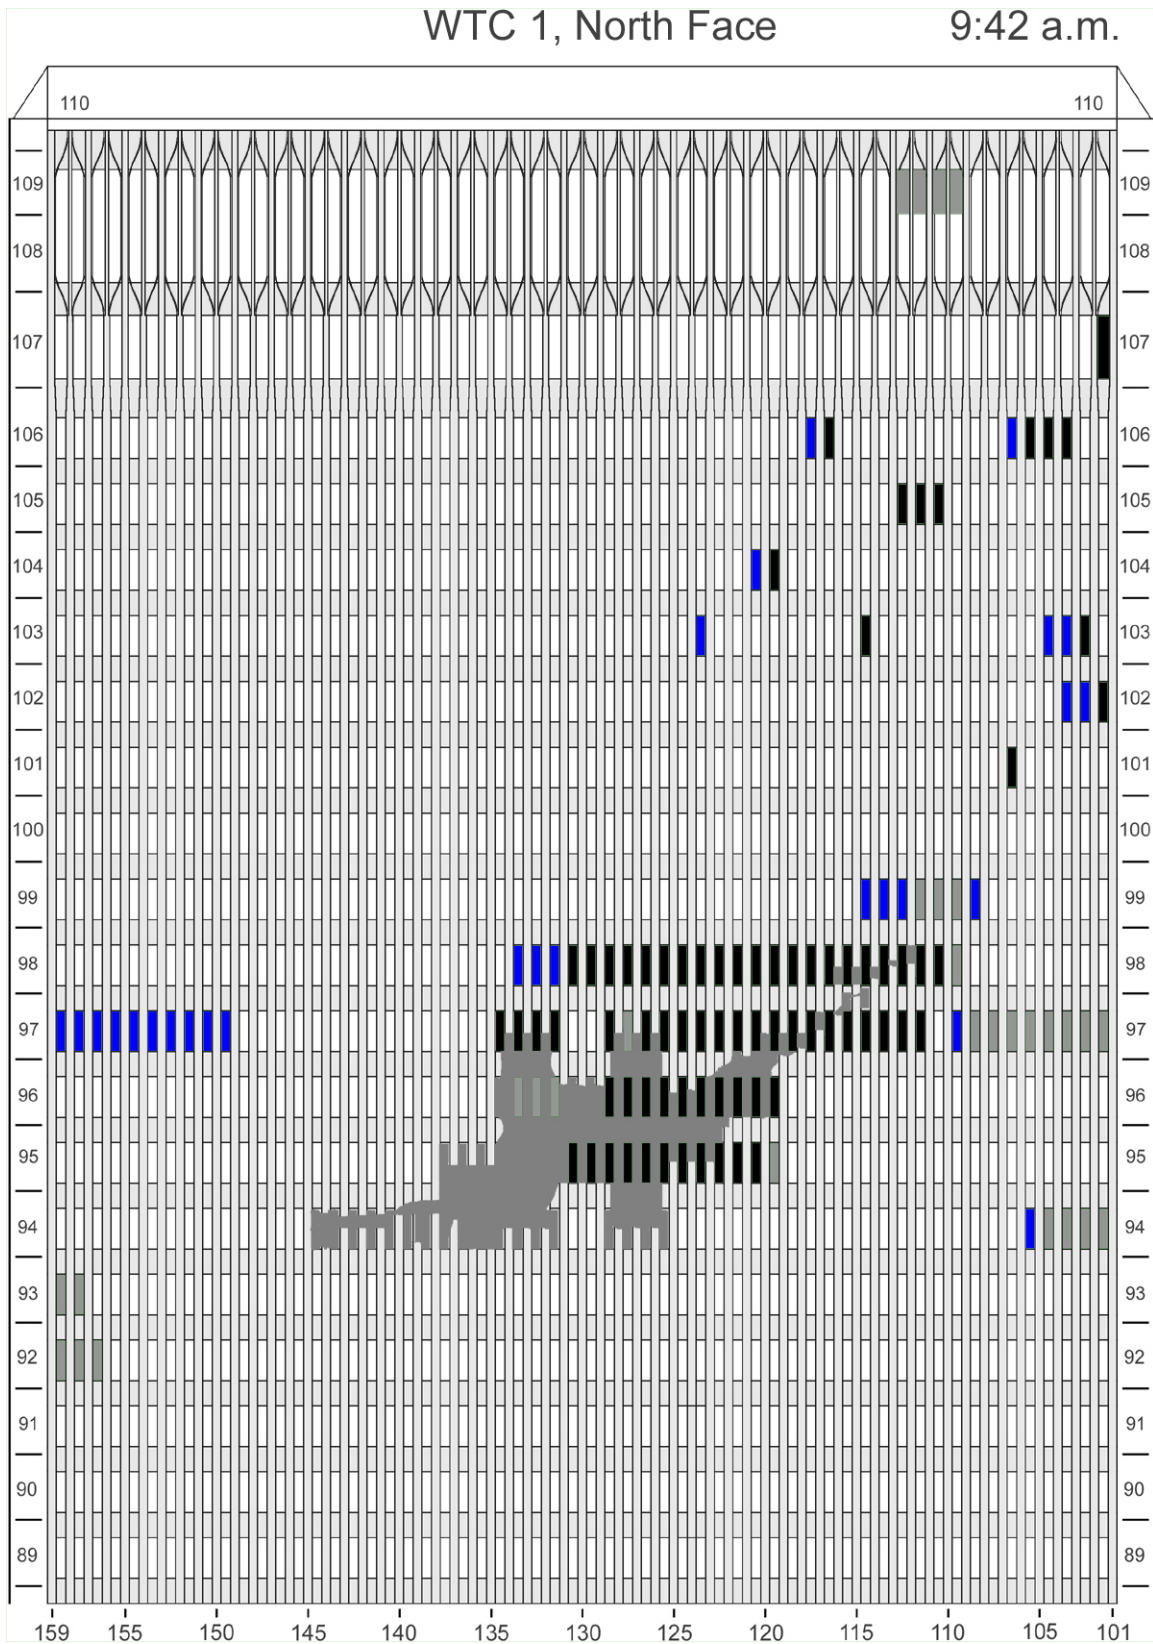
Figure C-36. Diagram of the north face of WTC 1 for floors 89 to 110 at 9:42 a.m. showing windows where smoke was observed and those that were hidden from view.
